Evaluating Corrosion of the Steel Liners of the Red Hill Tanks

Work Being Done to Safely Store Fuel at Red Hill

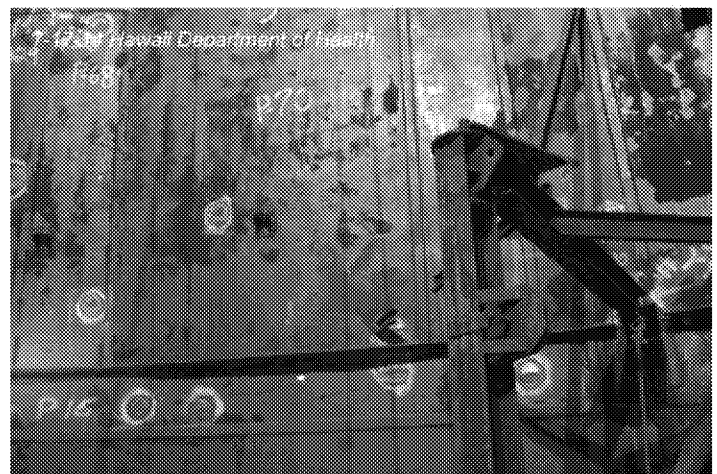
Low Frequency Electronic Testing

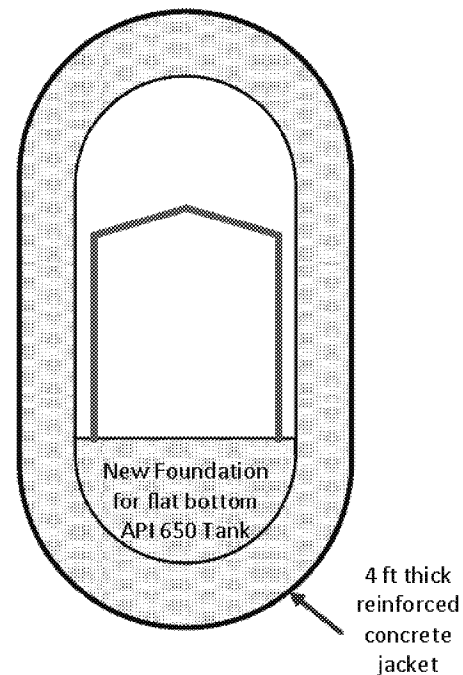
Alternate 3A

3A Double Wall—Tank within a Tank

- ♦ Construct new steel tank with five foot accessible annular space
- ♦ Existing steel liner provides secondary containment
